SAF/10/025

# Safety Alert

## Incident Involving MEWP Fire

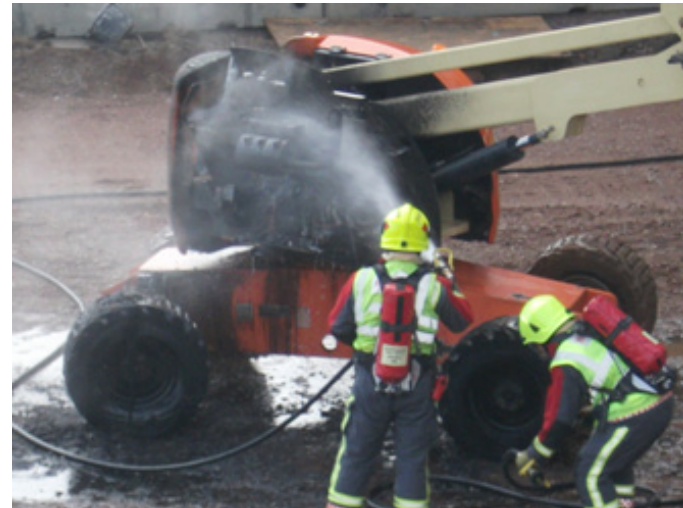
The operator was working at an approximate height of 5m when the fire started on the engine side of the 'base unit'. Other operatives noticed the fire and attracted the operator's attention who immediately started to lower the basket. After lowering the basket approximately 2m, the MEWP cut out and the operator was unable to bring it down on auxiliary power, (most likely because the battery was badly damaged by the fire). The fire also meant that no one could reach the emergency descent controls.

Left with little choice, the operator climbed over the guardrails and dropped to the ground – a distance of approximately 1.5m. He was not hurt.

1. The MEWP was defective in so much that it seems probable there was a leak of fuel or oil in the engine compartment. **PLEASE NOTE: 'NO' daily plant inspection form was completed for the MEWP nor had one been completed previously.**
2. The Risk Assessment stated that a designated ground man must be in place during all operations of a cherry picker. This wasn't implemented and so the detection of the fire and subsequent rescue of the operator was delayed.

1. All elements of the risk assessments for working at height are being implemented – and if circumstances require a Ground Man to be deployed, that this person is adequately trained.
2. A dry powder fire extinguisher is available in case of an emergency.
3. Daily inspections are completed for all MEWPs including those operated by sub-contractors.
4. A plan for carrying out an emergency rescue is in place and tested regularly.

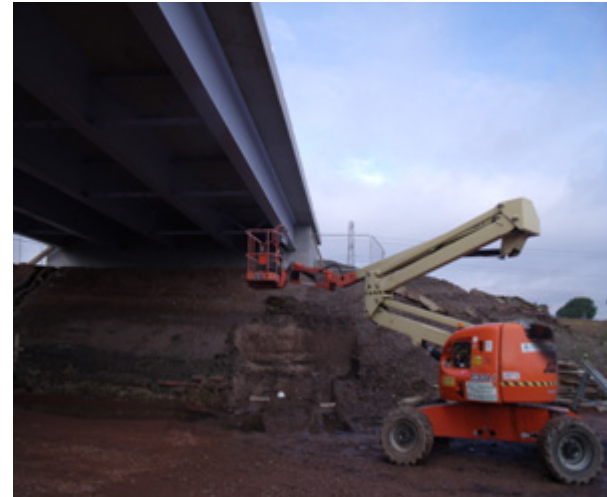
The main implication of this incident is the safety of the occupants in a MEWP basket should a base unit catch fire in the future. If the occupant was higher in the air, or perhaps working over water for example, the outcome could have been very different. The recommendations are therefore to prevent a reoccurrence of this incident rather than address evacuation procedures.
