**Pedestrian Struck by Vehicle resulting in Classified Injury**

**Traction No. 1835503**

Grangemouth, Scotland

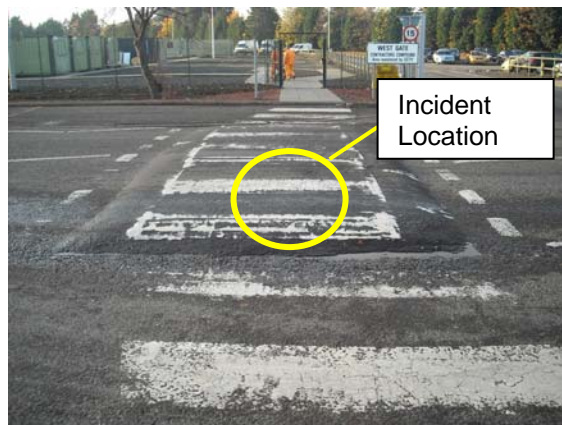
**Figure 1 - Road Crossing at Site Gate Entrance**

The injured party was on the designated crossing point at the time of the accident. (See Figure 1 below) The accident occurred during daylight hours and the injured party was wearing high visibility clothing.

The Investigation has confirmed that the windscreen of the vehicle involved in the incident was not fully de-misted before driving and therefore contributed to the driver not seeing the contractor employee on the road crossing.

1. Pre use vehicle checks must be carried out daily by the driver in order ensure the vehicle has full visibility and is fit for purpose.
2. A formal system should be in place for documenting competent drivers who are authorised to drive company vehicles on site.
