SAFETY ALERT.

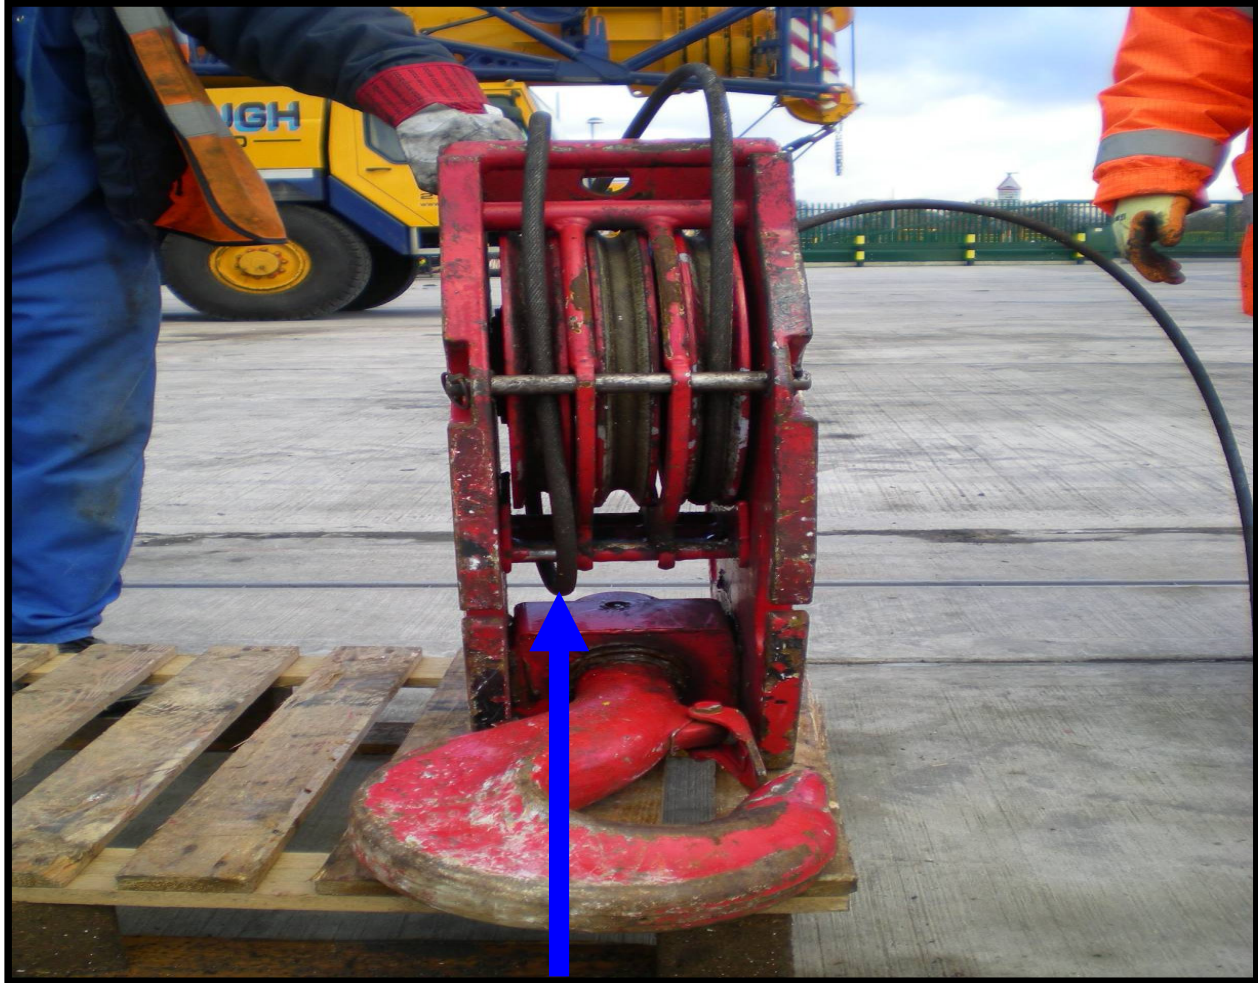
When changing from two falls to four falls, an experienced crane operator reeved the hoist rope **UNDER** the hook block sheave guard. **This resulted in the hoist rope SNAPPING during the lifting operation, and the 11 tonne vessel which was being lifted falling 3mts to grade.**

On this occasion, the crane operator was being assisted by a rigger who had passed the rope to him under the sheave guard.

The operator failed to check that the rope was positioned correctly.

Don't become distracted by others, double check your work and always **GET OUT OF THE CAB!!!**

Inspect and confirm that the hoist rope is running in the correct sheaves and that the retaining pins are correctly positioned.
